ASTRO PAK®

CHLORIDE-INDUCED PITTING CORROSION OF  
AUSTENITIC STAINLESS STEEL

DATE: 08/20/2018

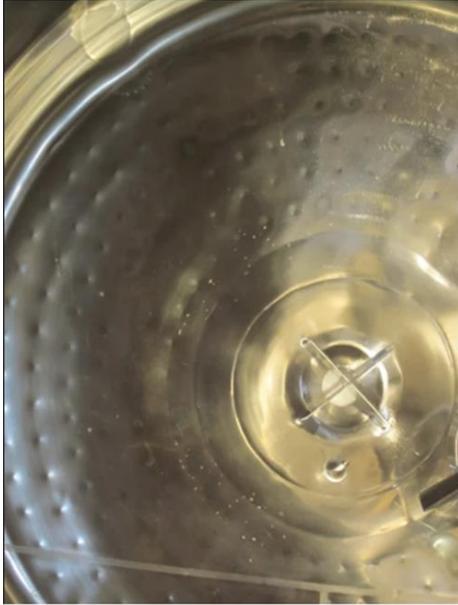
1.

The photographs strongly suggest that chloride-induced pitting corrosion is taking place. The observed visible pits, the whitish hazing of the surface, and the white streaks are all consistent with pitting corrosion. It is known that the stainless steel has been in contact with a product that contains 0.1N HCl, further suggesting that the pitting corrosion is chloride-induced.

dissolution of the metal, which can cause rapid penetration of the full metal thickness. In many cases pitting corrosion is not detected until severe damage occurs, such as complete penetration in sheet or tube material. This is due to the very small pit holes formed on the surface, which can be covered by corrosion products from a pit attack, effectively creating a lid on top of the pit, with only a very small opening as a result. This creates a situation where fluid exchange is minimal. This can make rinsing ineffective as a method of removing the chloride ions from the pit, especially as the pit deepens. The lack of fluid exchange also means that passivating with the pits uncorrected is ineffective. Pits must be polished away (MP or EP).

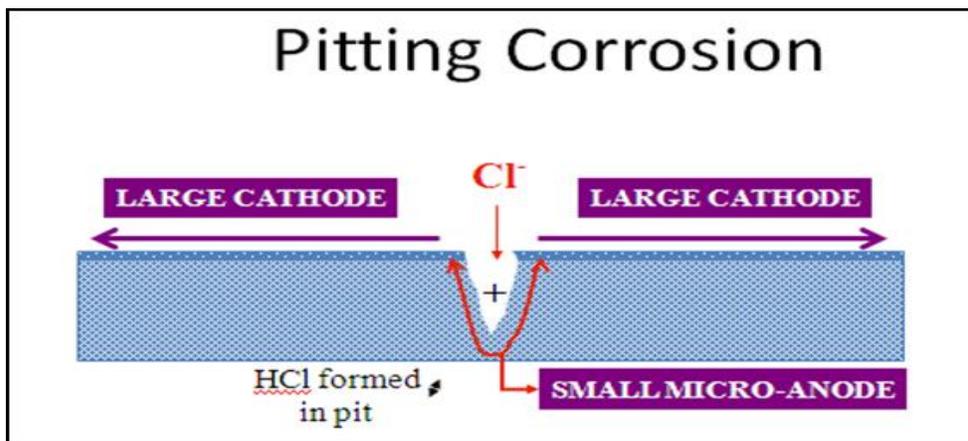
FIGURE 1:

Pitting corrosion is a localized form of galvanic corrosion. It is initiated at a local imperfection in the passive layer, which can be the site of an inclusion, or a stressed area from bending or forming, or damage from impact (among other causes). Pitting corrosion takes place in neutral or acidic solutions containing chlorides ( $\text{Cl}^-$ ). The chloride ion penetrates the imperfection and begins the process of pit initiation.

The chloride ion creates a localized anode that is surrounded by the large cathode which is the undamaged surface. The rate of the growth of the pit (pit depth) accelerates as the pit progresses, with a time v depth curve that is parabolic.

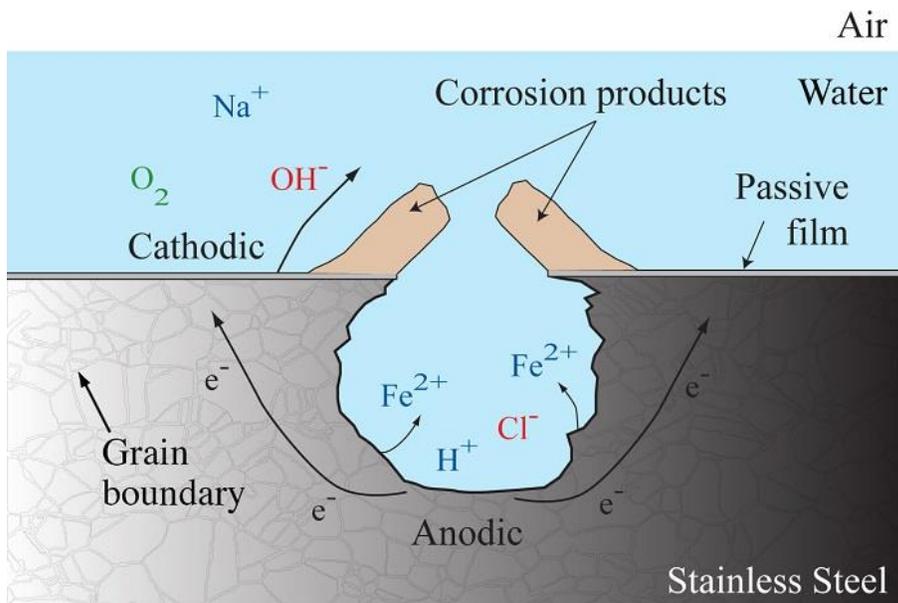
FIGURE 3:

As chloride in solution enters the pit, it spontaneously forms HCl (hydrochloric acid), which attacks the alloy. Iron atoms are removed via dissolution from the alloy crystalline structure, reacting and forming ferric hydroxide (expressed in chemical shorthand as Fe(OH)<sub>3</sub>). As noted above, the rate of metal loss accelerates as the pit deepens. Factors that influence pitting rate include Cl<sup>-</sup> content, pH value, temperature, and the presence of oxidizing agents.
